2022

Root Cause Analysis of Tube Leakage for an Ammonia Converter Effluent Cooler / Steam Generator

Jerry Zhang, Sr. Technical Advisor, Proprietary Process Technologies & Equipment

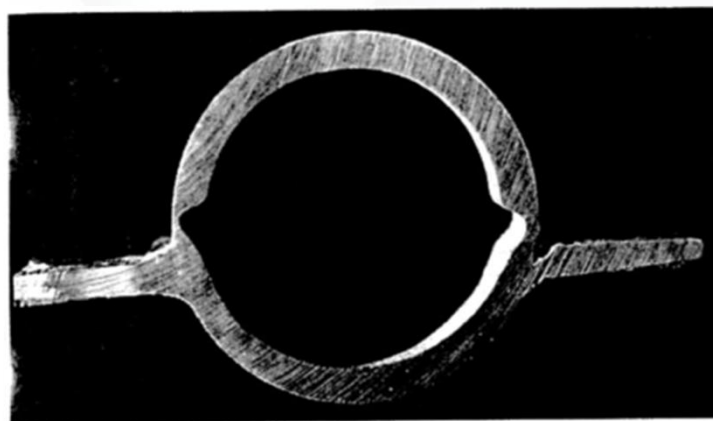
Borescope images indicated root line along inside tubes, such area are corresponded to shell inlet gas at first baffle turn, those area are high flux area. Borescope images cannot be displayed at this moment. The Borescope image looks very similar to Caustic gouging along a longitudinal water line. See below sketch from a book regarding Caustic corrosion.

Figure 4.4 Caustic gouging along a longitudinal waterline. (Courtesy of National Association of Corrosion Engineers.)

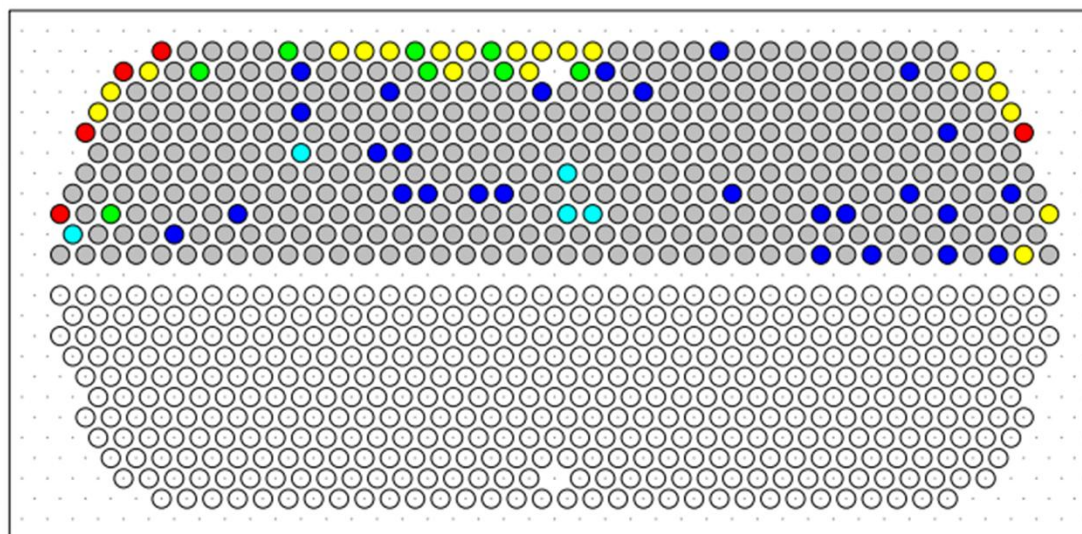
ECA (Eddy Current Array) have been done as well in order to check all the tubes condition, below is the mapping of tubes with defect tube location in related to tube layout.

0 ● PLG: Plugged	27 ● 20 < Defect <= 40
5 ● 80 < Defect <= 100	5 ● 0 < Defect <= 20
20 ● 60 < Defect <= 80	345 ● No Defect Detected
8 ● 40 < Defect <= 60	410 ○ Not Tested

According to the ECA report, there are (5) five tubes which have wall loss approaching 100%. Most of the tubes with wall loss are near fourth baffle, as counted from the U-bend which is shown in previous sketch. After discussing this with the heat exchanger manufacturer, it is reported that the baffle holes exceed TEMA limits. According to the manufacturer’s inspection report, another factor is possibly due to tube bundle insertion.

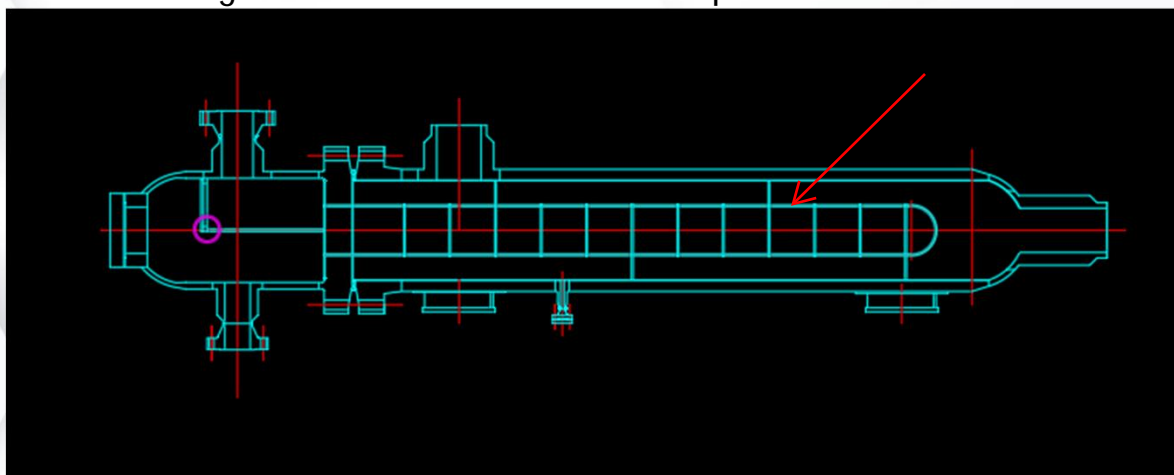
According to KBR design, around 14% evaporation is expected, but, according to client operation data, evaporation ratio is over 35%, after further investigation, it is found out that BFW flowrate is less than KBR process design which indicated BFW starve in this heat exchanger. Short of BFW caused higher evaporation rate at the local high flus area where damaged tubes are located.

The damaged tubes are located at the below location where arrow pointed, damaged tubes are located at outer perimeter of the tube.

Those damaged tubes are located at high flux area where syngas inlet toward first baffle turn area.

The damaged tubes are plugged according to tube plug procedure provided by manufacturer and plant are back to production, future metallurgical analysis in damaged tubes are recommended. KBR also suggest client seek help from BFW treatment specialist to control BFW quality for normal operation.
