SOLVING DIFFICULT CASES OF THERMAL EXPANSION

Pasadena, TX November 16, 2022 Jamal Jamalyaria, P.E. Flexitallic US, Director of Engineering

Hydrotreater Mechanical Outage Extension Feed/Effluent Exchanger Large Refinery, Port Arthur, TX

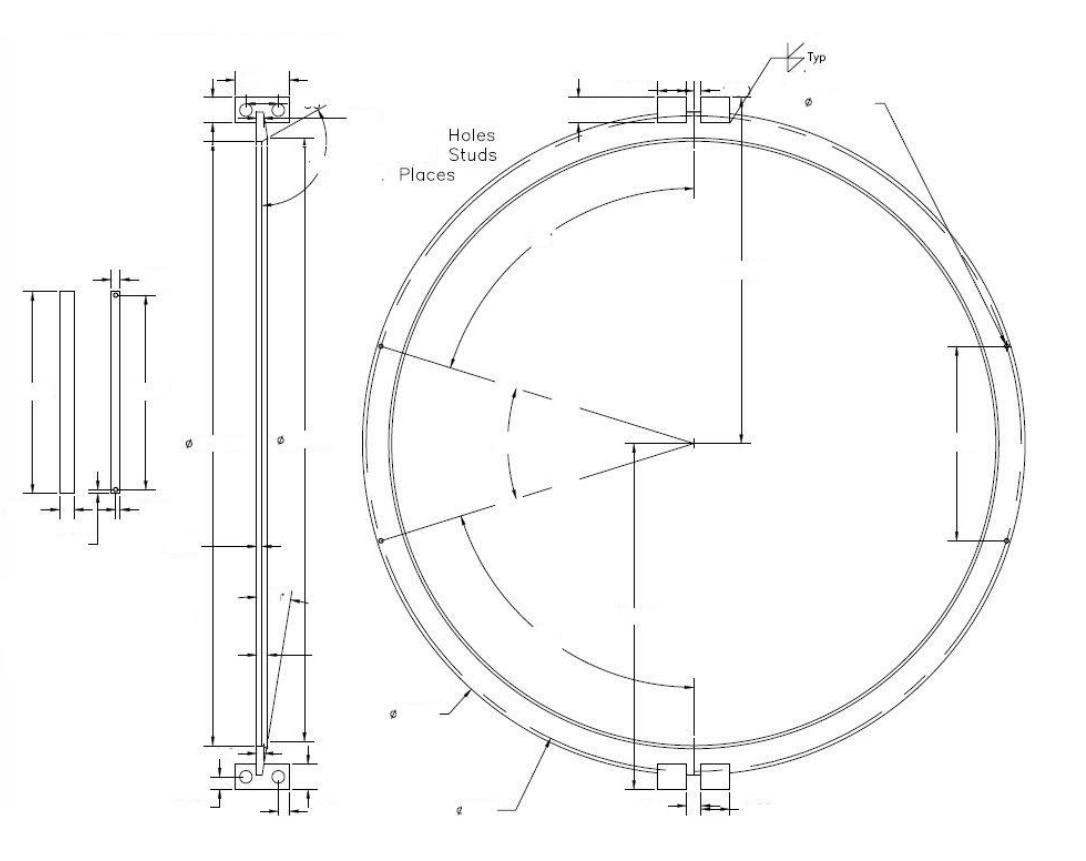
- Exchanger girth flange develops leak after thermal cycling event
 - First attempt to stop leak was by torquing
 - Torquing is unsuccessful
 - Bolts were initially tensioned and bolt nuts are dry
 - Difficult to torque accurately considering no lubrication and size of bolts
 - Leaking girth flange is clamped
 - Clamp is marginally successful
 - Clamp requires periodic re-pumps
 - Clamp leaks after thermal events or feed rate changes

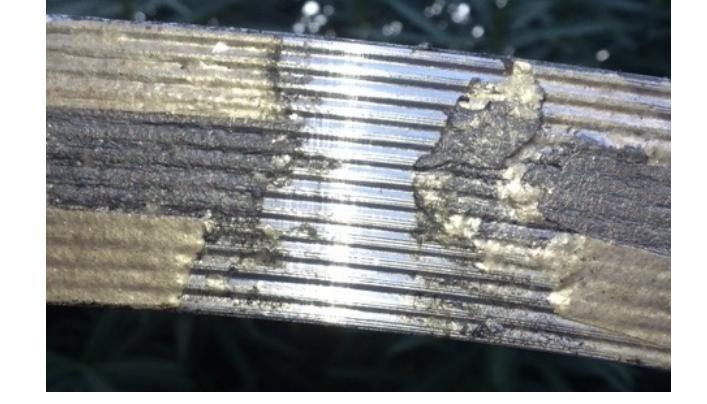
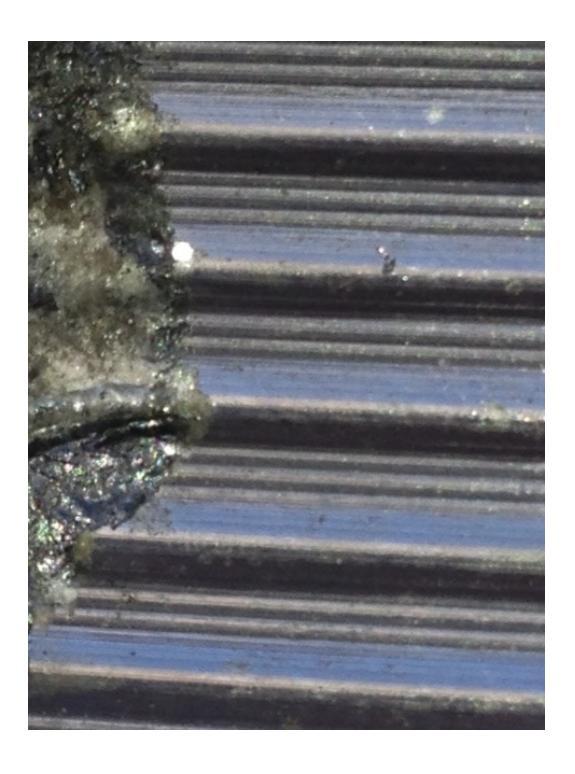
Experienced "blow-out" of thick corrugated gasket during hydro-test.

- Gasket would seep water during ramp up of hydro-test pressure
- Seeps were stopped by re-torquing
- Additional torquing possibly rotated flanges causing them to become nearly metal bound

Possibly rotated flanges unload the corrugated gasket
- Gasket "blows out" prior to reaching full hydrotest pressure
 - Post mortem revealed gasket filler material separated (slipped) from core and damages (dents) to core are observed

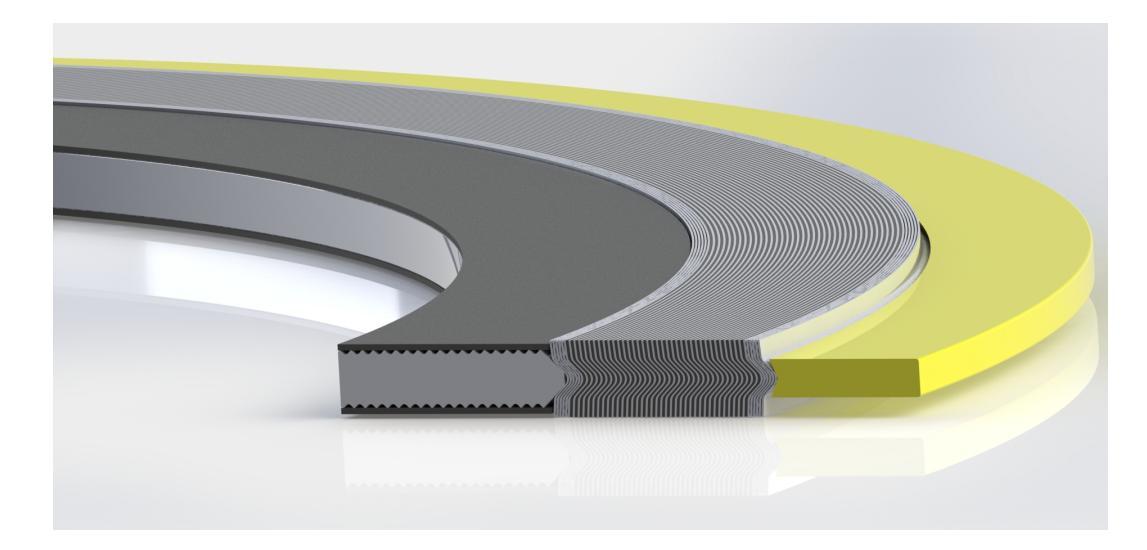
Hybrid Gasket passed hydro-test.

- Hybrid gasket does not seep water during hydro-test ramp up
- Additional torquing is not required during hydro-test
- Any rotation of flanges do not cause unloading of the gasket as the inner gasket acts as compression stop

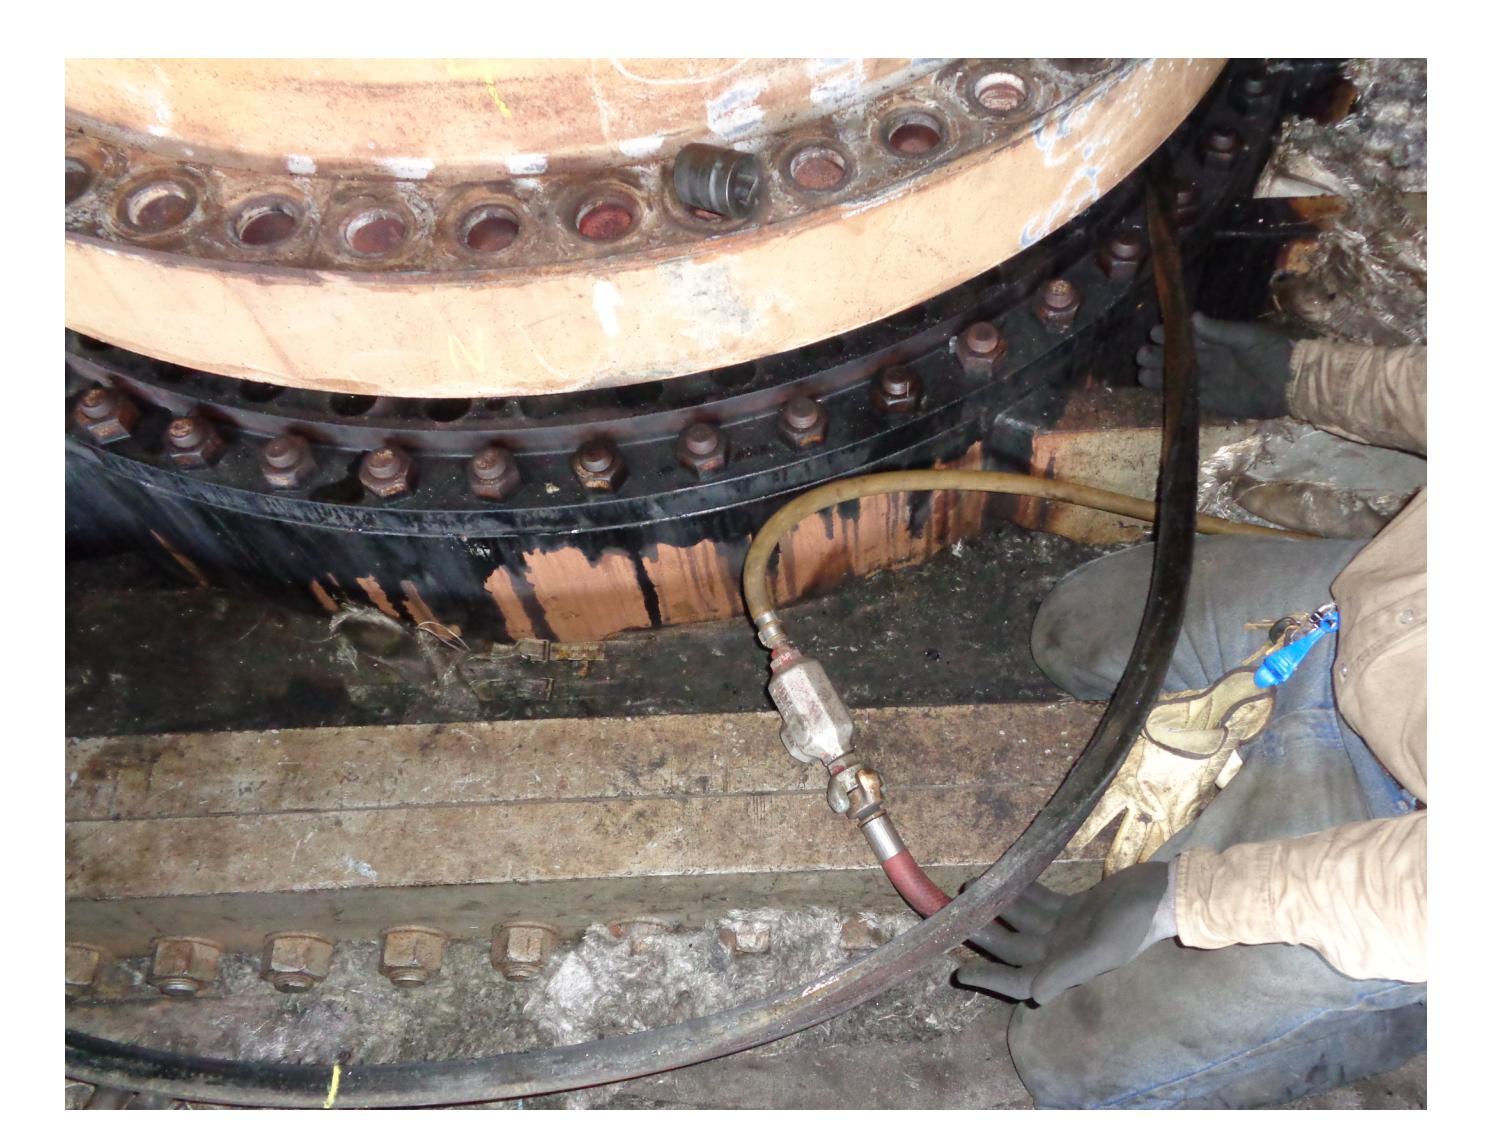
Bottom Unheading Valve- Coker

- Relatively new drums (6 each)
- Original gasket type Corrugated Metal Gasket
- Gaskets were deformed badly, and blew out in short time
- Gasket was upgraded to Grooved metal "Kammprofile"
- Kammprofile last a little longer, but deformed after a while as well
- No room for a thick Carrier Ring type we had success with in the past
- Use of tabs with holes or full-face not possible due to space limitations (not all bolts could be removed)
- Severe constant thermal cycles simply would ruin the gaskets in time possibly due to the extremely high radial forces
- They did an FEA thermal analysis showing hot spots and cold spots causing the gasket to be pulled inward
- We used Shear Plates strong enough to be higher than the friction forces pulling the gasket

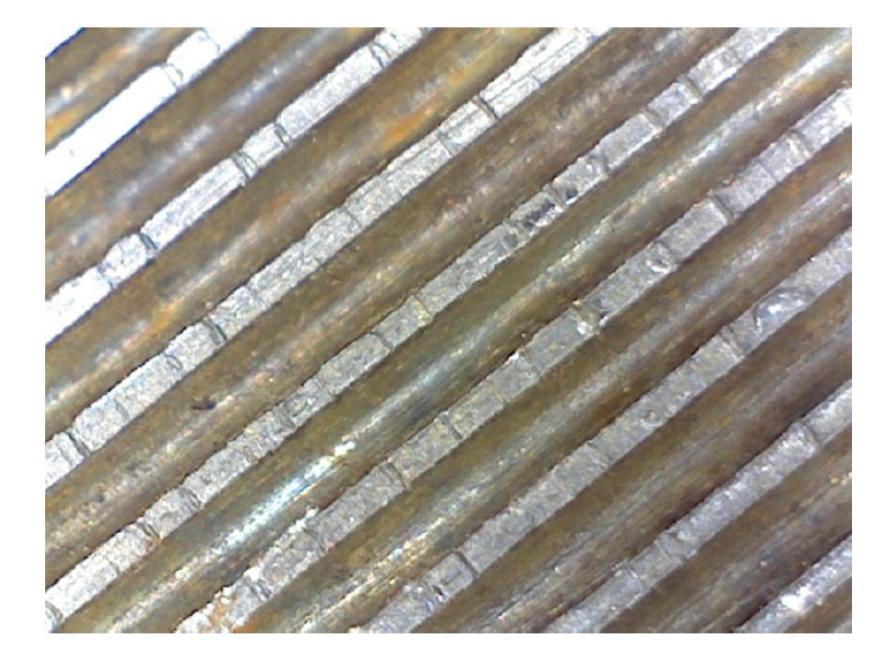
Image 312 - Gripper Marking on groove tips - Left Side (Image 2) Magnified

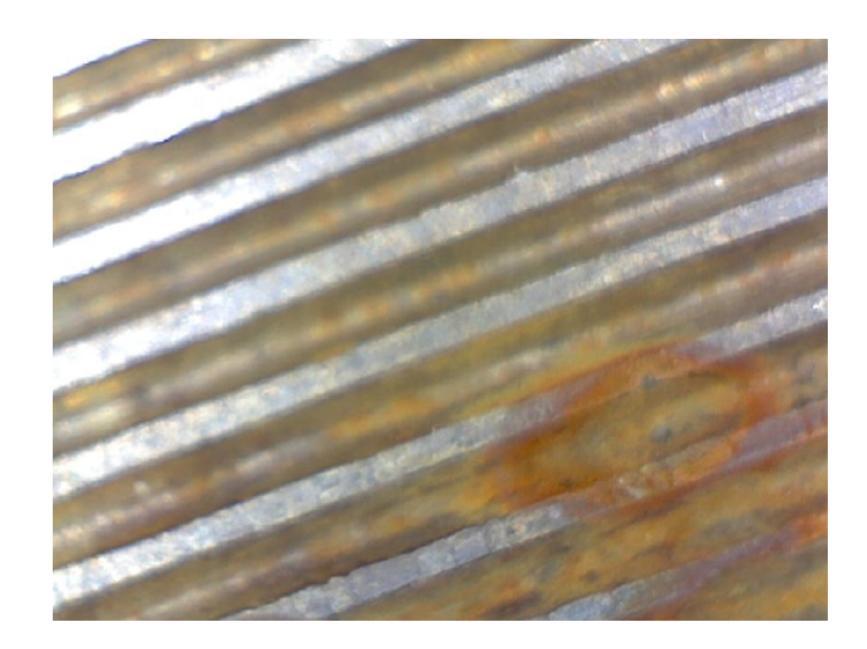
Img 313 - Opposite Side, portion inboard of raised face sticking into bore, opposite face from heavy carbon deposit.
