2022

Root Cause Analysis of Tube Leakage for an Ammonia Converter Effluent Cooler / Steam Generator

Jerry Zhang, Sr. Technical Advisor, Proprietary Process Technologies & Equipment

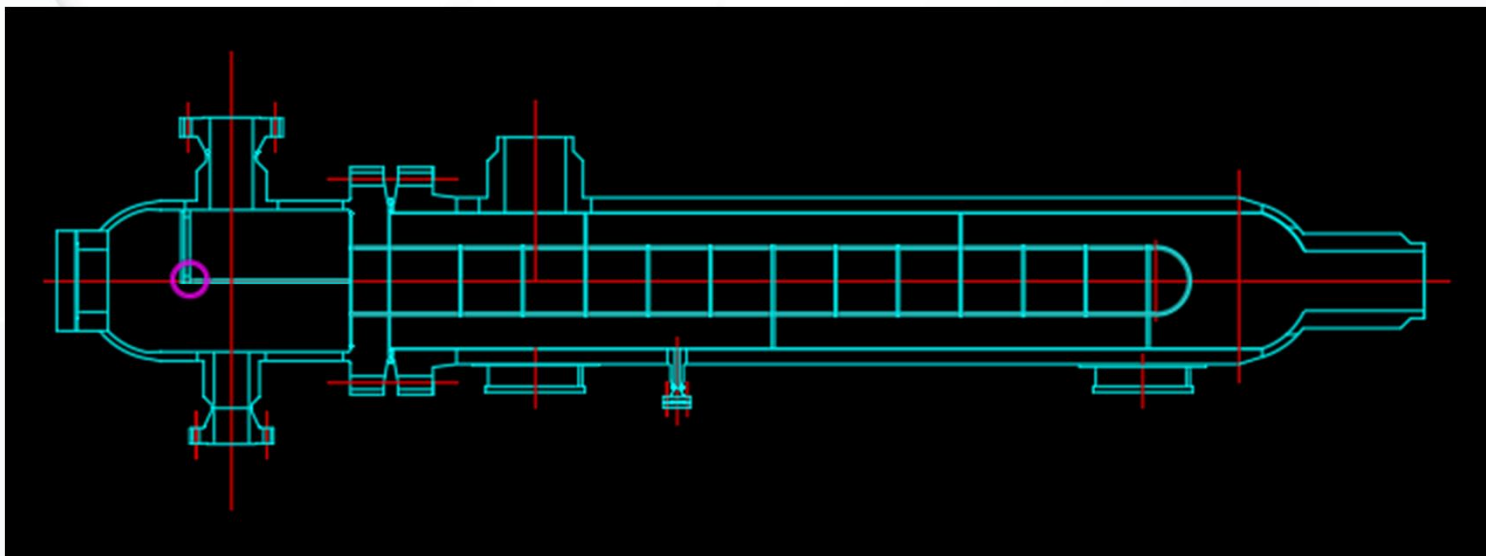
General Arrangement
Ammonia Converter Effluent Cooler / Steam Generator

The Ammonia Converter Effluent Cooler / Steam generator experienced failure (tube leakage) after put into service for about 1-year (within manufacturer's warranty), both KBR and the client wanted KBR to provide RCA (Root Cause Analysis) on the failure of this heat exchanger based upon the observations and limited tests and examinations.
