SOLVING DIFFICULT CASES OF THERMAL EXPANSION

Pasadena, TX November 16, 2022 Jamal Jamalyaria, P.E. Flexitallic US, Director of Engineering

Hydrotreater Mechanical Outage Extension Feed/Effluent Exchanger Large Refinery, Port Arthur, TX

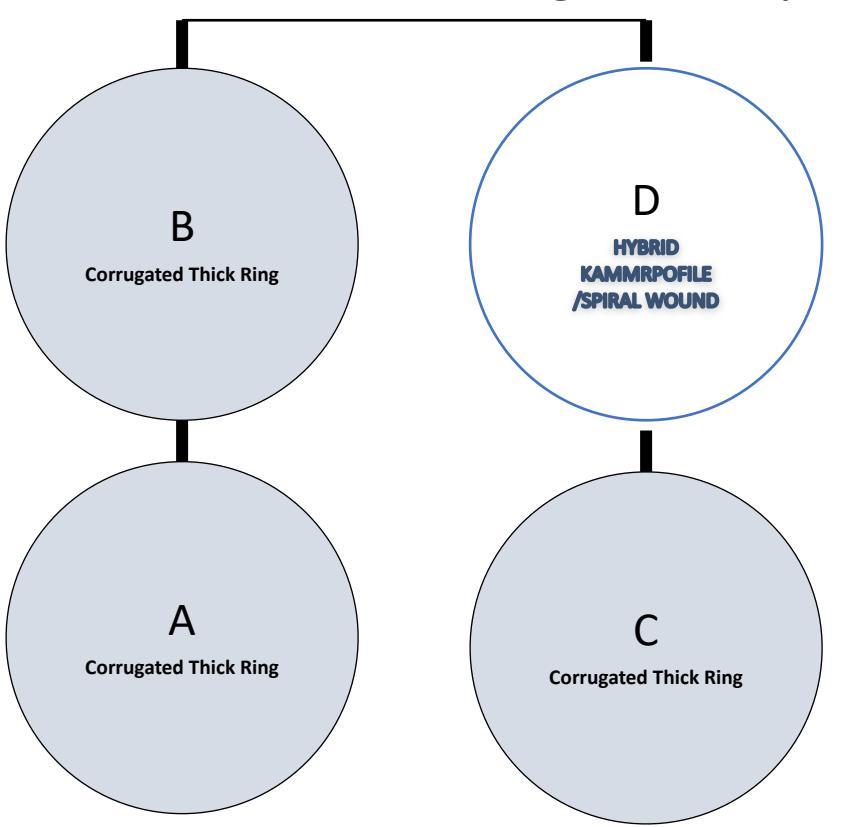
- Two gasket designs are installed during outage to test performance.
 - (1) Hybrid Kammprofile inner-ring, spiral wound outer-graphite filler
 - (3) Thick Corrugated Ring with Mica/Graphite/Mica (Picked to achieve some saving as the hybrid gasket was more expensive

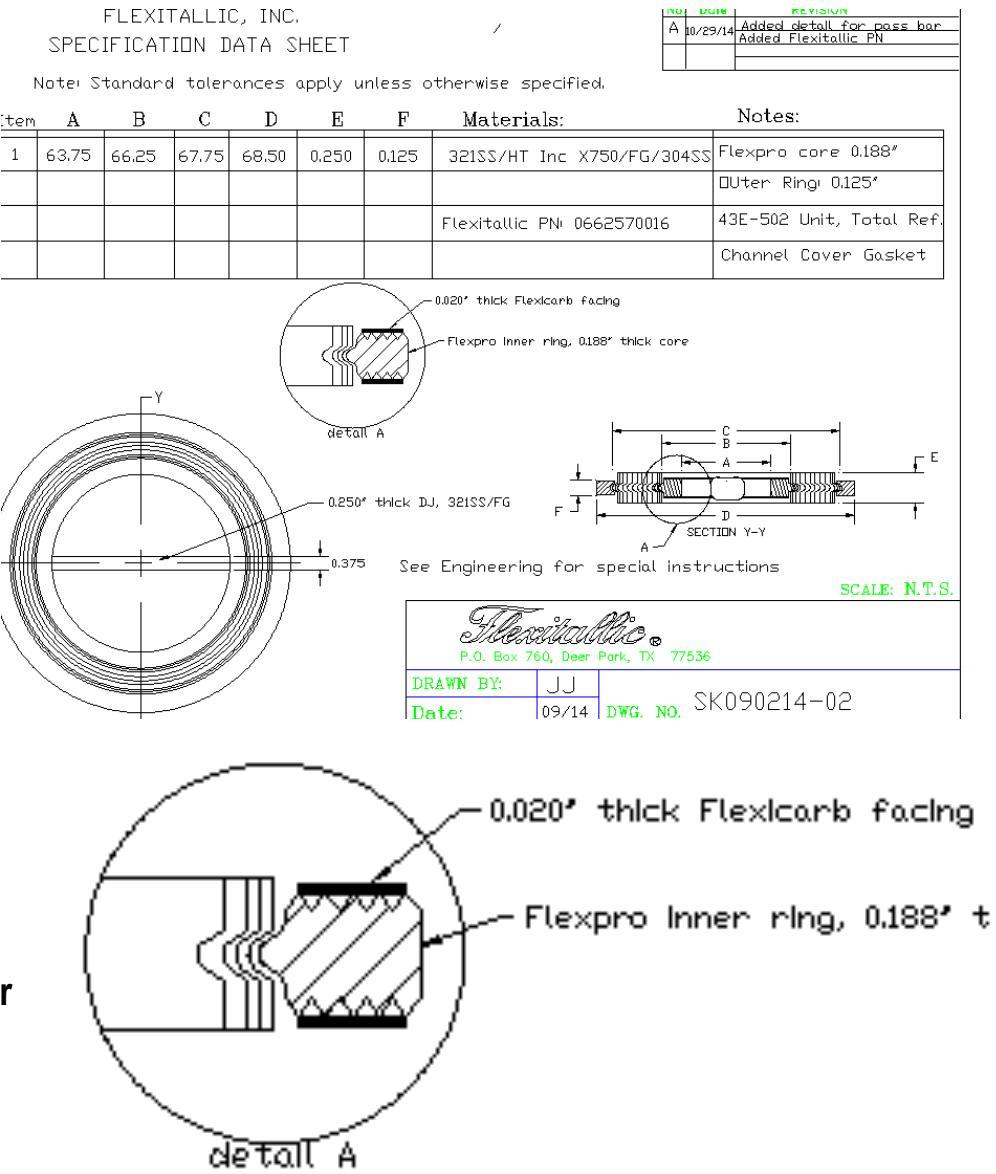
Experienced "blow-out" of thick corrugated gasket during hydro-test.

- Gasket would seep water during ramp up of hydro-test pressure
- Seeps were stopped by re-torquing
- Additional torquing possibly rotated flanges causing them to become nearly metal bound

Possibly rotated flanges unload the corrugated gasket
- Gasket "blows out" prior to reaching full hydrotest pressure
 - Post mortem revealed gasket filler material separated (slipped) from core and damages (dents) to core are observed

- Special Kammprofile inner/SW outer
- The inner 0.188" thick Flexpro to act as torque stop
- The outer SW with HT inconel X750 will not be unloaded due to excessive bolt load
- The thin (0.125") outer ring will NOT act as stop
- Not heard from them for a couple of months
- Suddenly ordered super rush delivery of 8 sets
- It turned out that they had used another type gasket which blew out during the hydro test, causing major cost and delay in start up, requiring emergency order for our gaskets

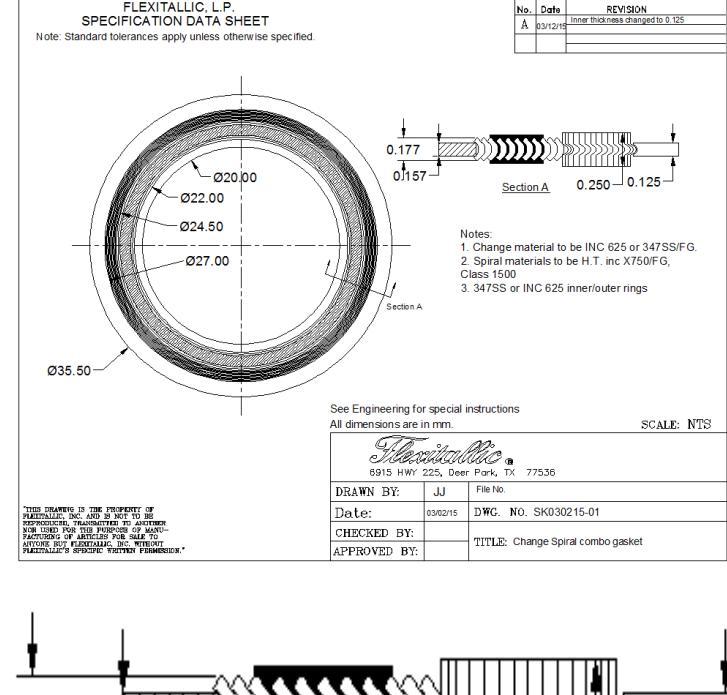
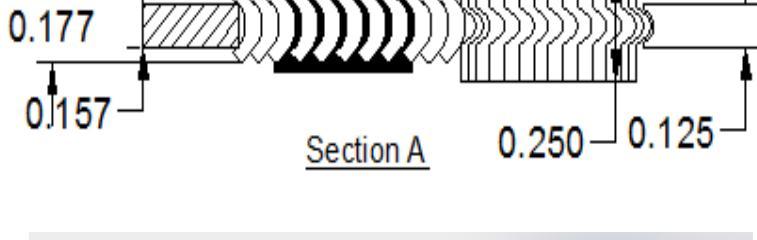
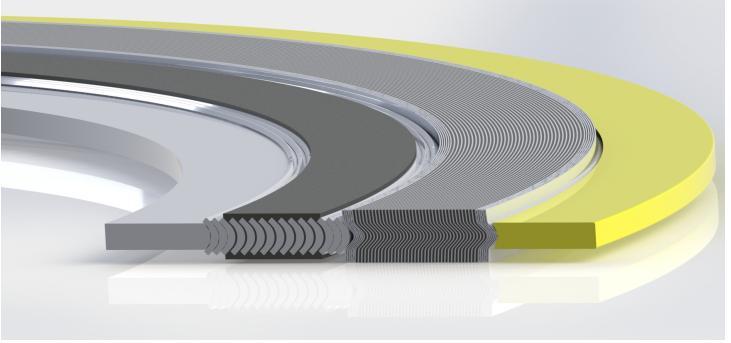
Problems with the Kamprofile gaskets used in Reactors of a prominent Refinery at 770 F

Flanges: 24", Class 1500 with dissimilar materials,
 Radial Shear, Cycling, possibility of flange Rotation
 Calculated radial shear: .020" (.010" allowable)

✓ Solution:

A Hybrid gasket using Change inner and SWG with HT inconel X750 winding outer gasket

The more rigid inner Change gasket acts as compression stop for the outer SWG with H T inconel X750

The outer ring is thin so it does not create flange rotation causing any unloading of the gaskets

Both the Change and the SWG are suitable for Radial Shear inherent in this application

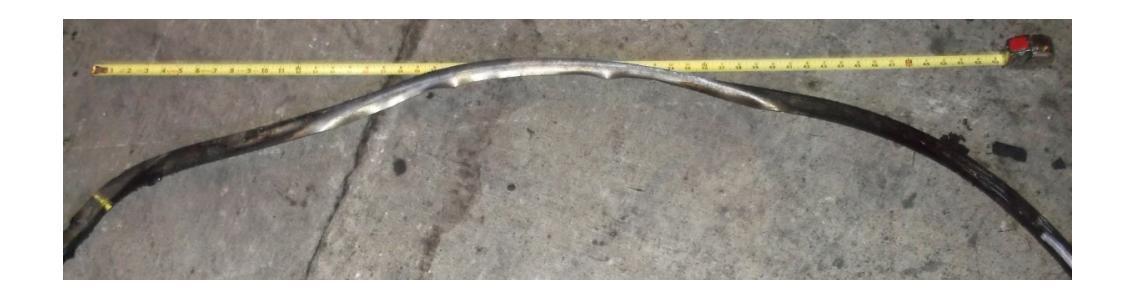
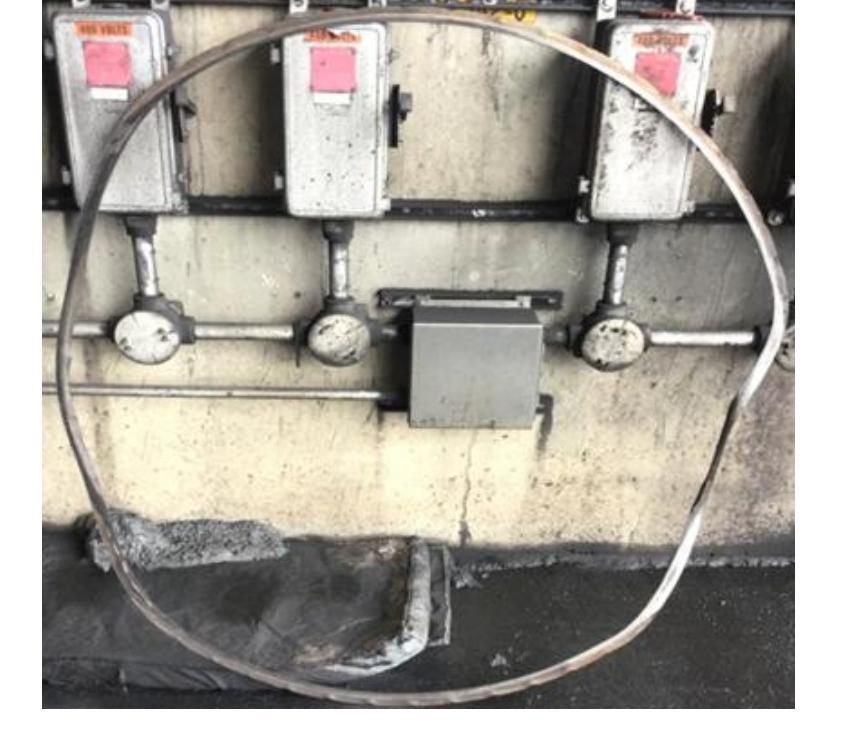
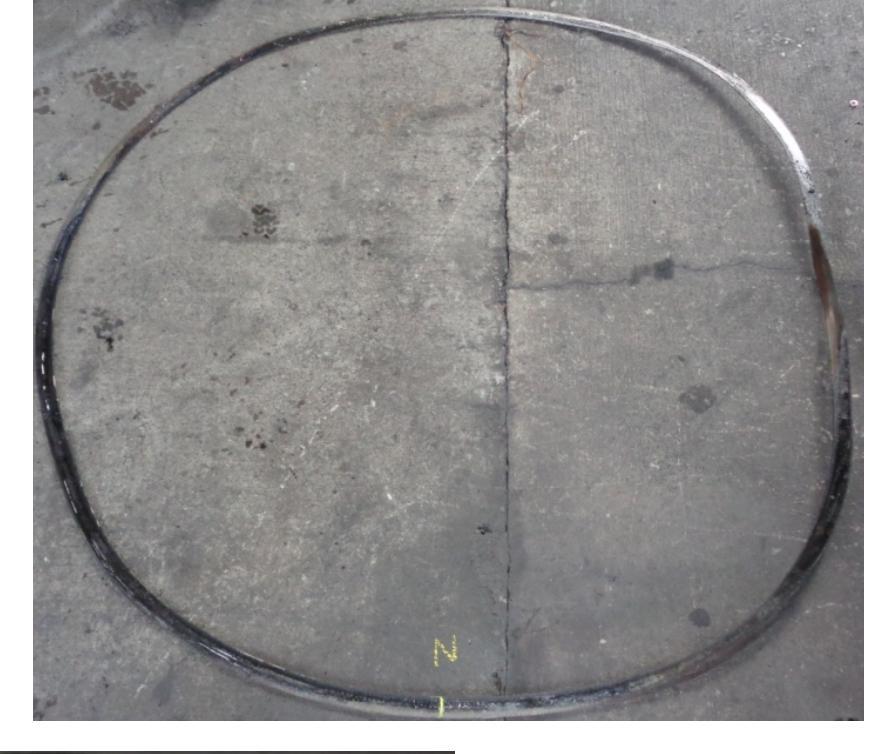
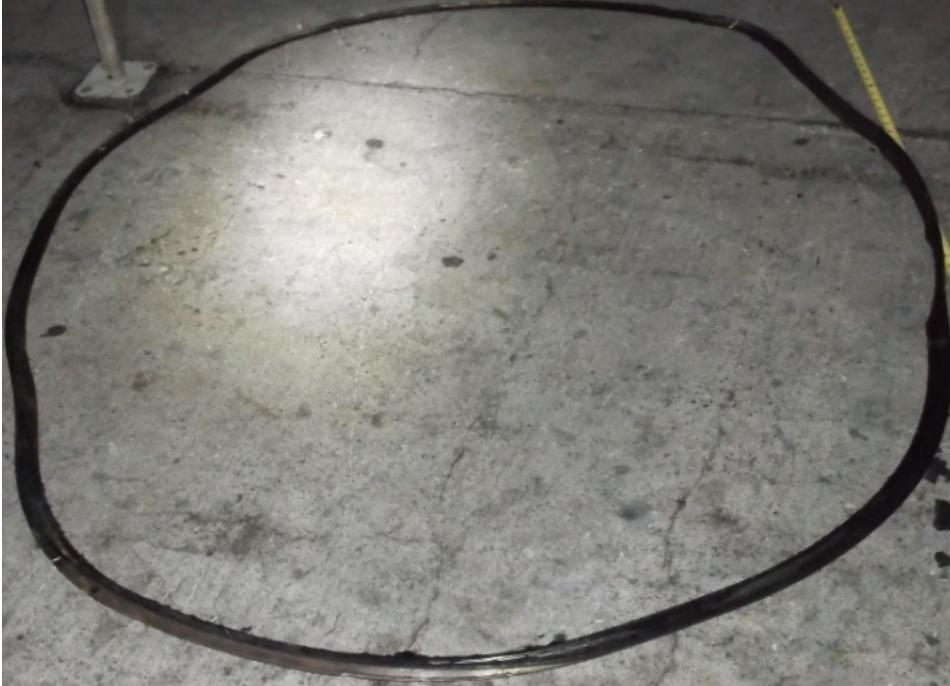
Bottom Unheading Valve- Coker

- Relatively new drums (6 each)
- Original gasket type Corrugated Metal Gasket
- Gaskets were deformed badly, and blew out in short time
- Gasket was upgraded to Grooved metal "Kammprofile"
- Kammprofile last a little longer, but deformed after a while as well
- No room for a thick Carrier Ring type we had success with in the past
- Use of tabs with holes or full-face not possible due to space limitations (not all bolts could be removed)
- Severe constant thermal cycles simply would ruin the gaskets in time possibly due to the extremely high radial forces
- They did an FEA thermal analysis showing hot spots and cold spots causing the gasket to be pulled inward
- We used Shear Plates strong enough to be higher than the friction forces pulling the gasket
